# CERTIFICATE OF COMPLIANCE

**Certified Product:** Rechargeable Li-ion Battery Storage System

**Model(s):** GE-FH60, GE-FL60

**Certified Product:** High Voltage Hybrid ESS/L3 Series LimitLess Lithium™

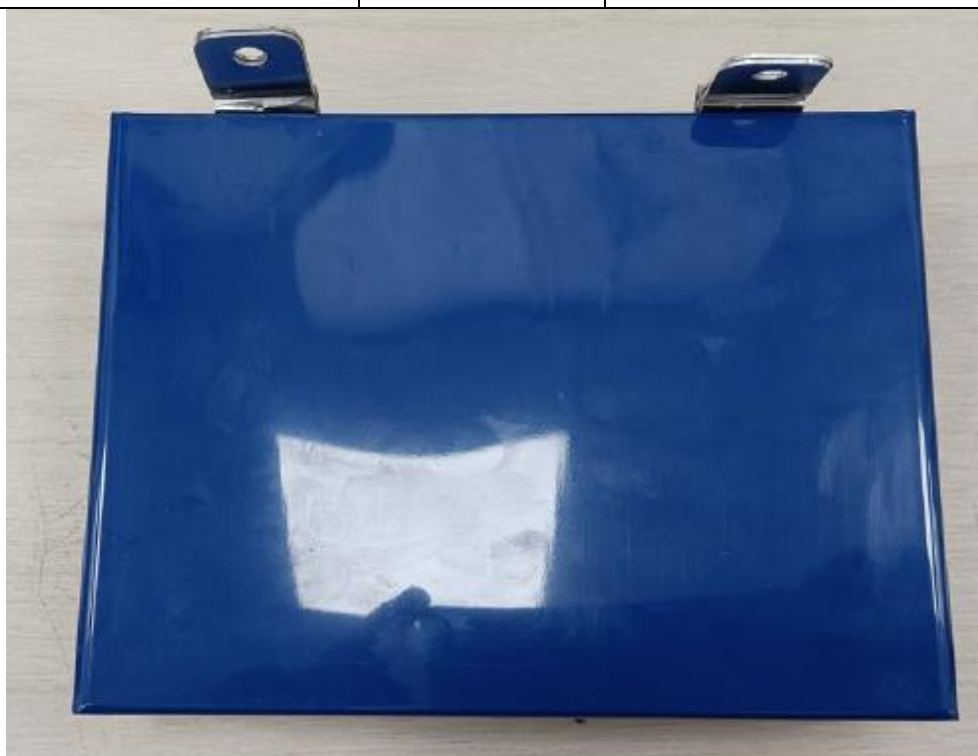
Figure 1. View 01 of component cell

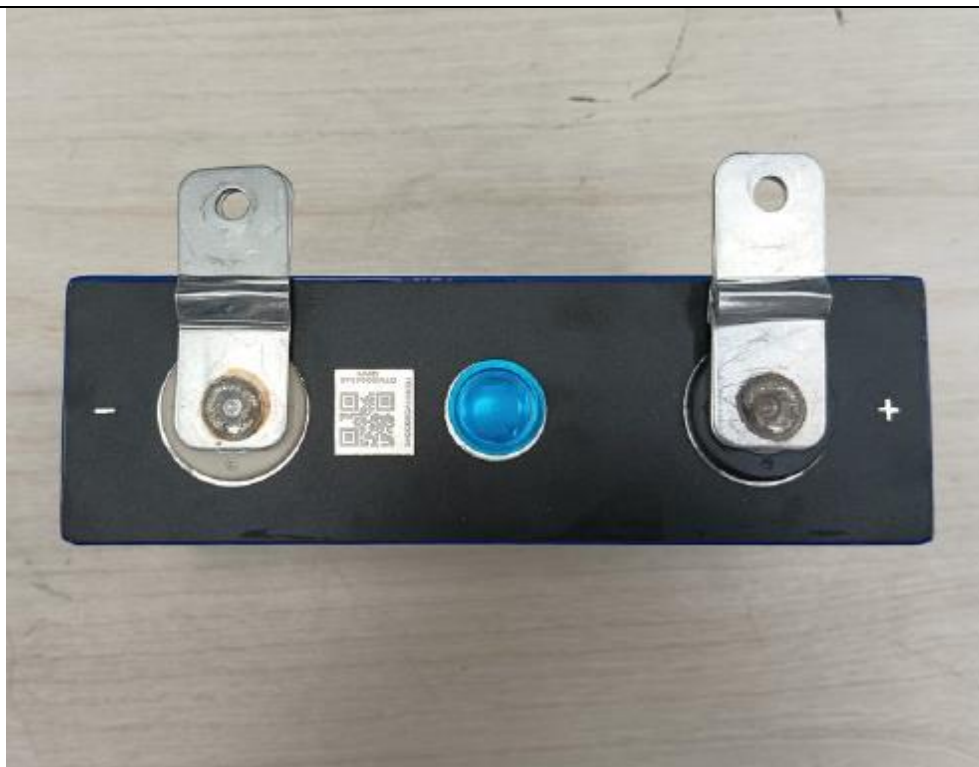
Figure 2. View 02 of component cell

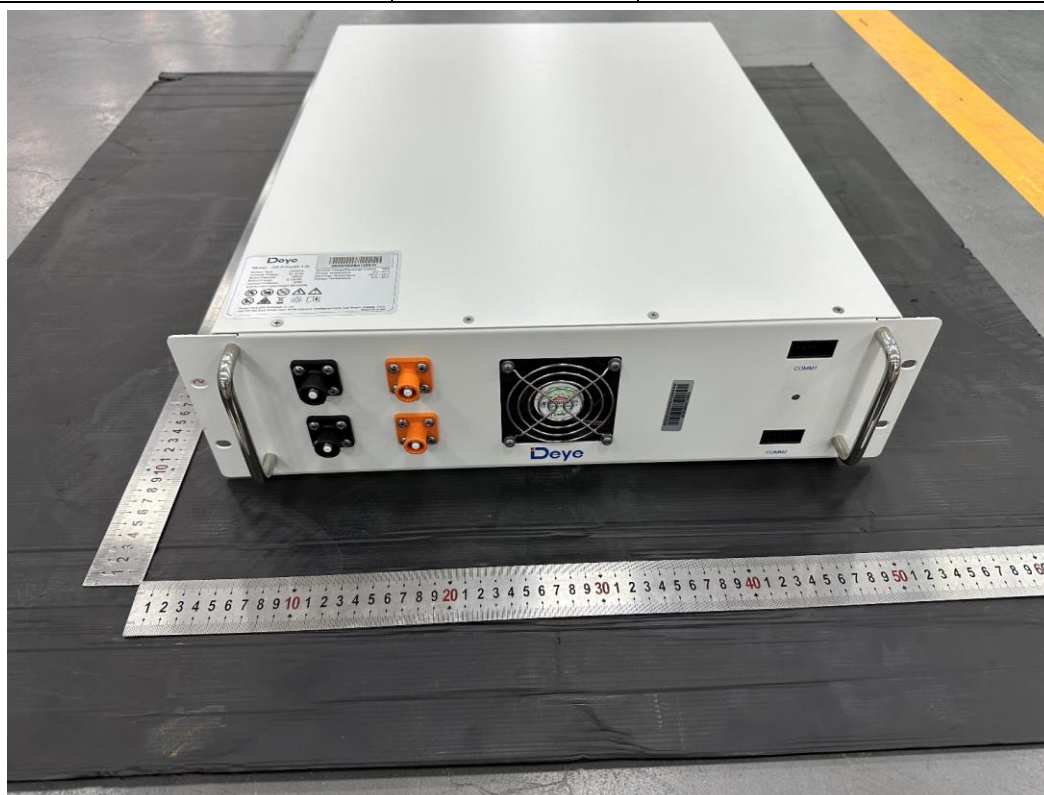
Figure 3. View of battery module

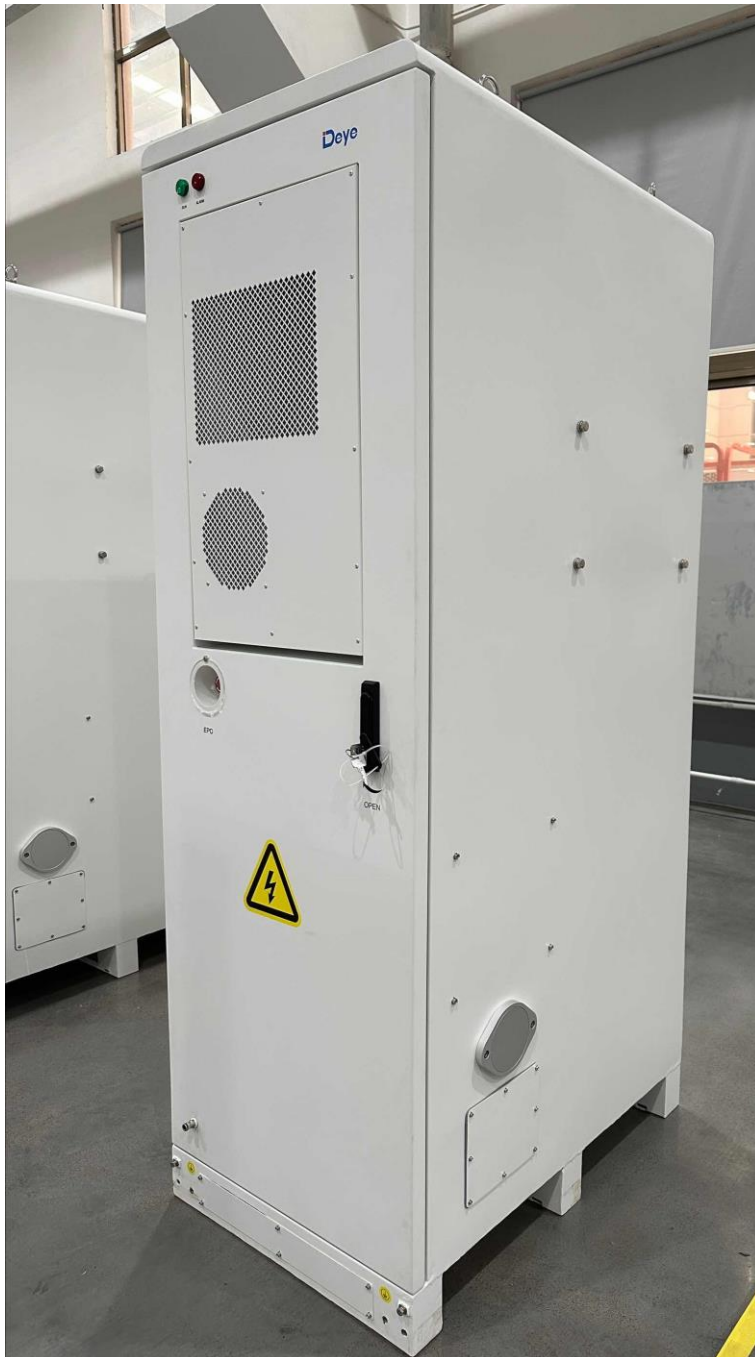
Figure 4. View of battery unit (GE-FH60)

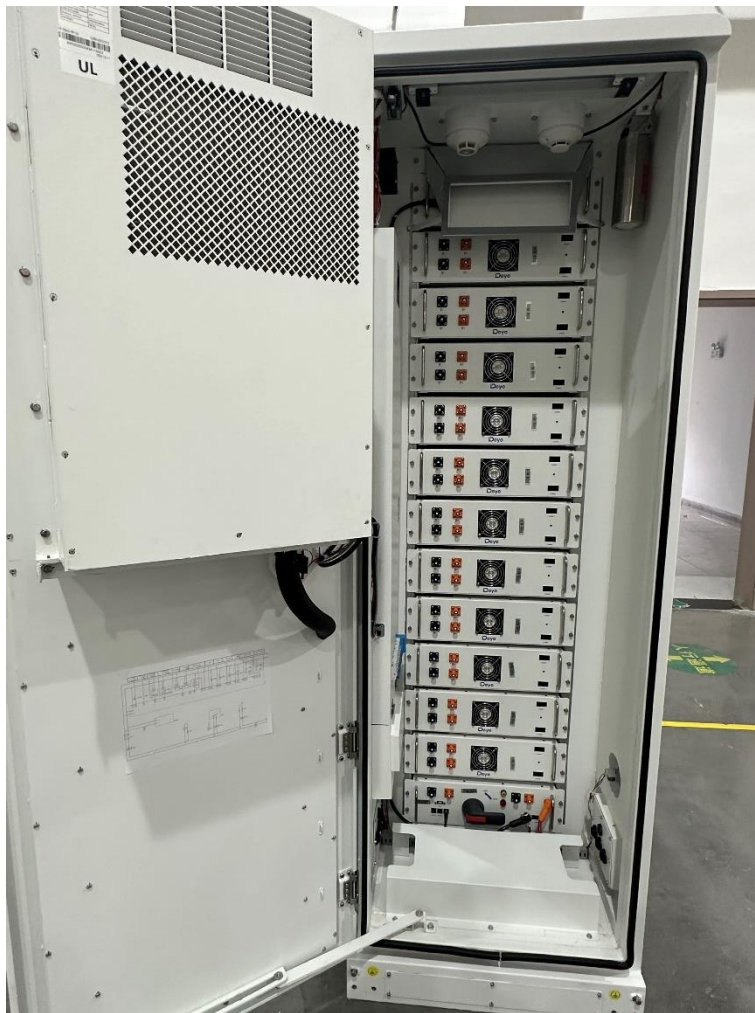
Figure 5. Internal view of battery unit (GE-FH60)

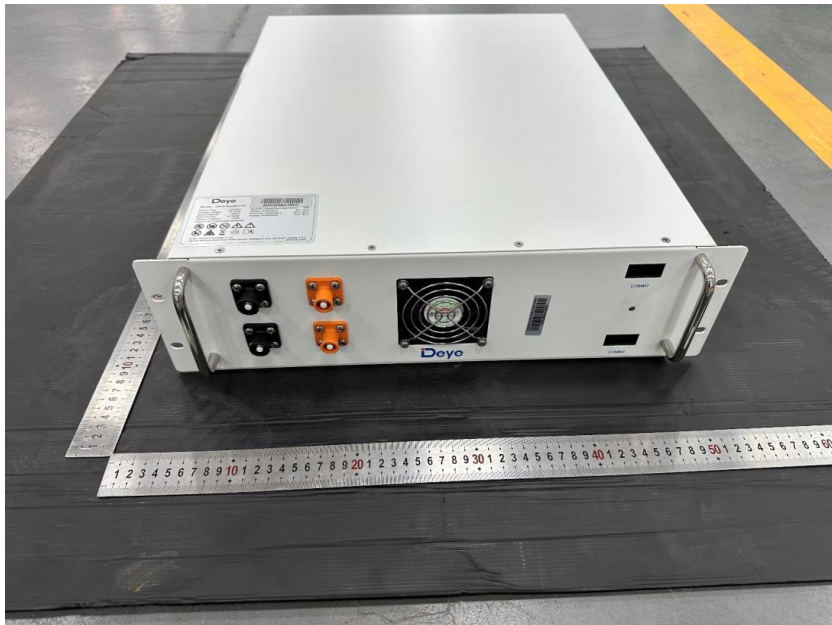
Figure 6. External view of battery module

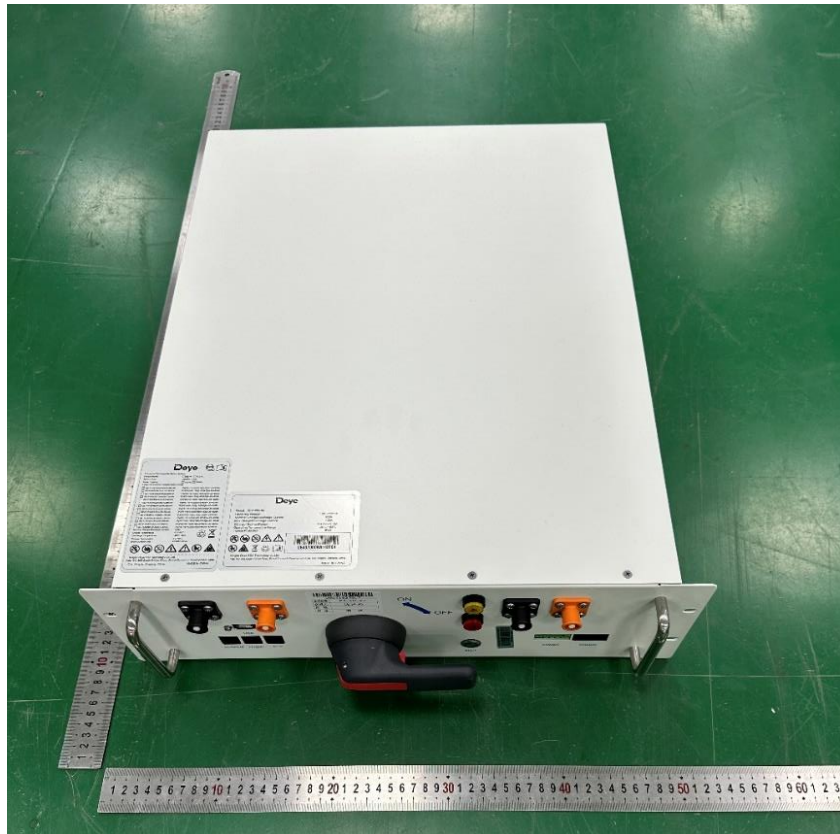
Figure 8. External view of control box

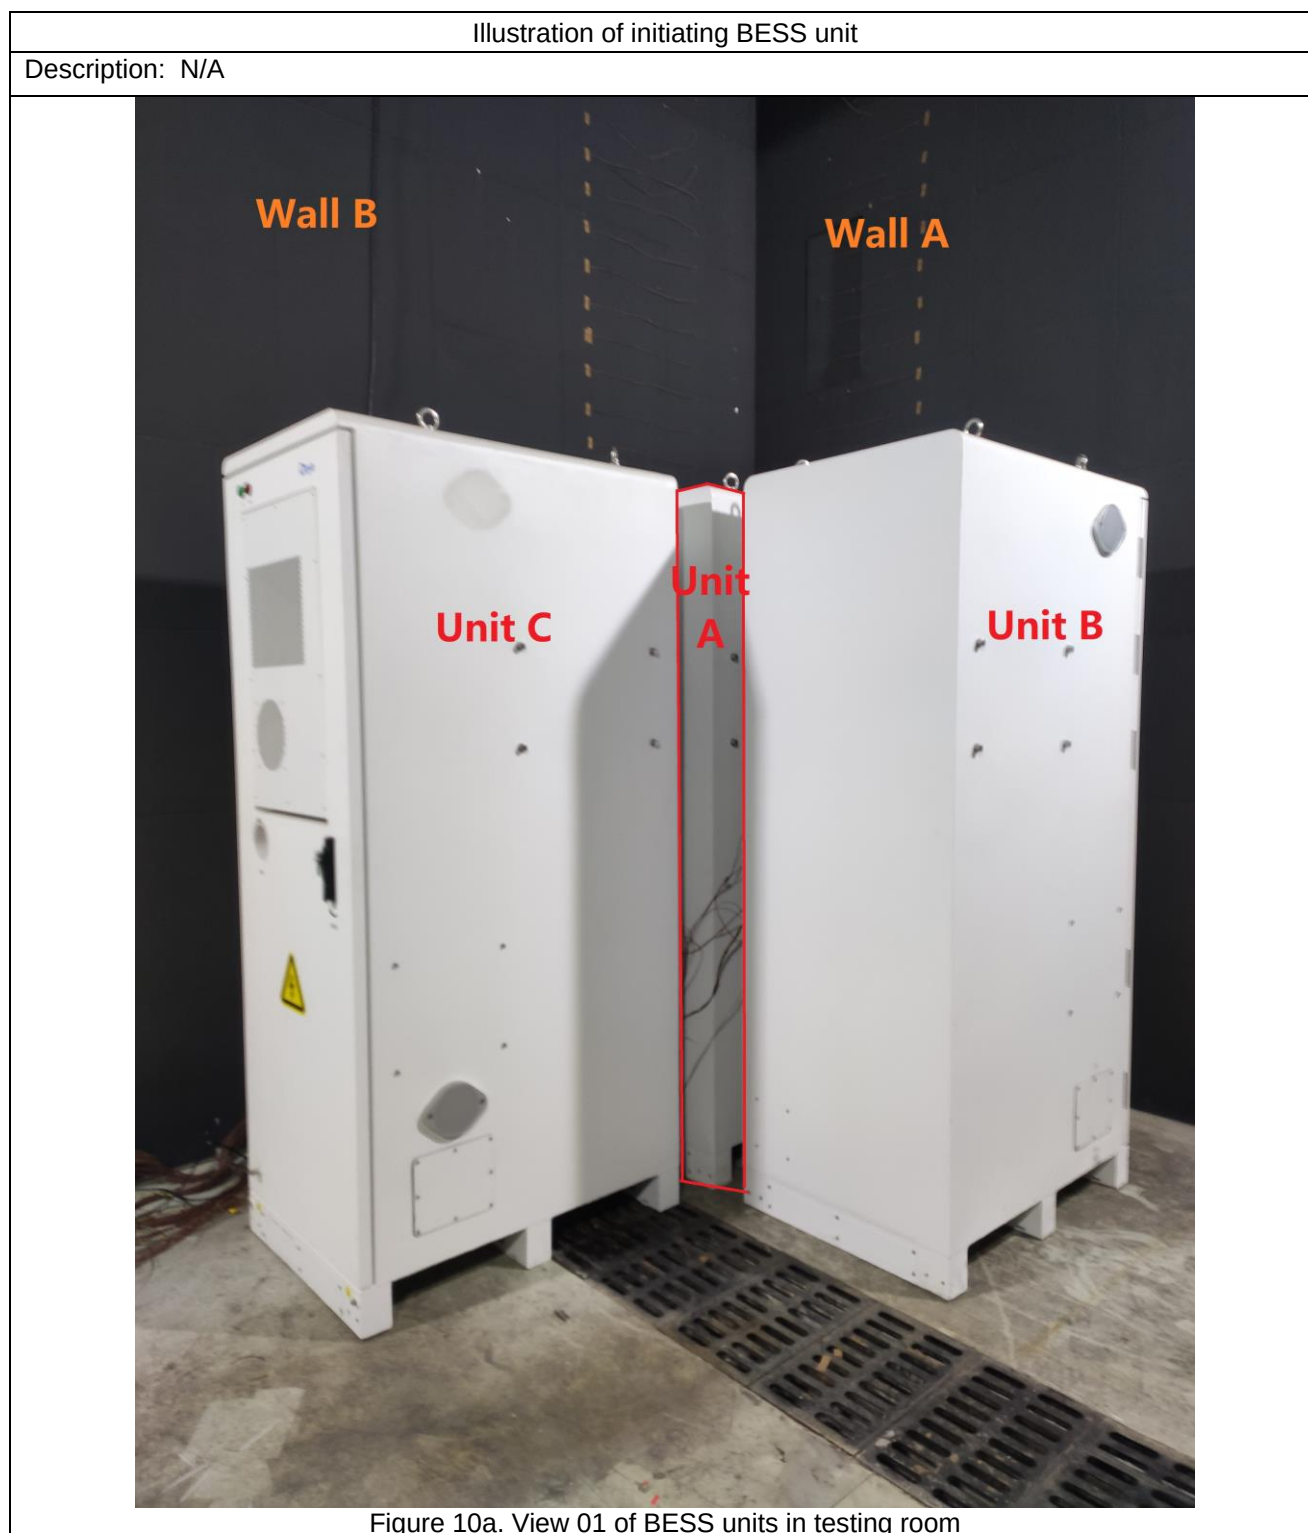
Figure 10a. View 01 of BESS units in testing room

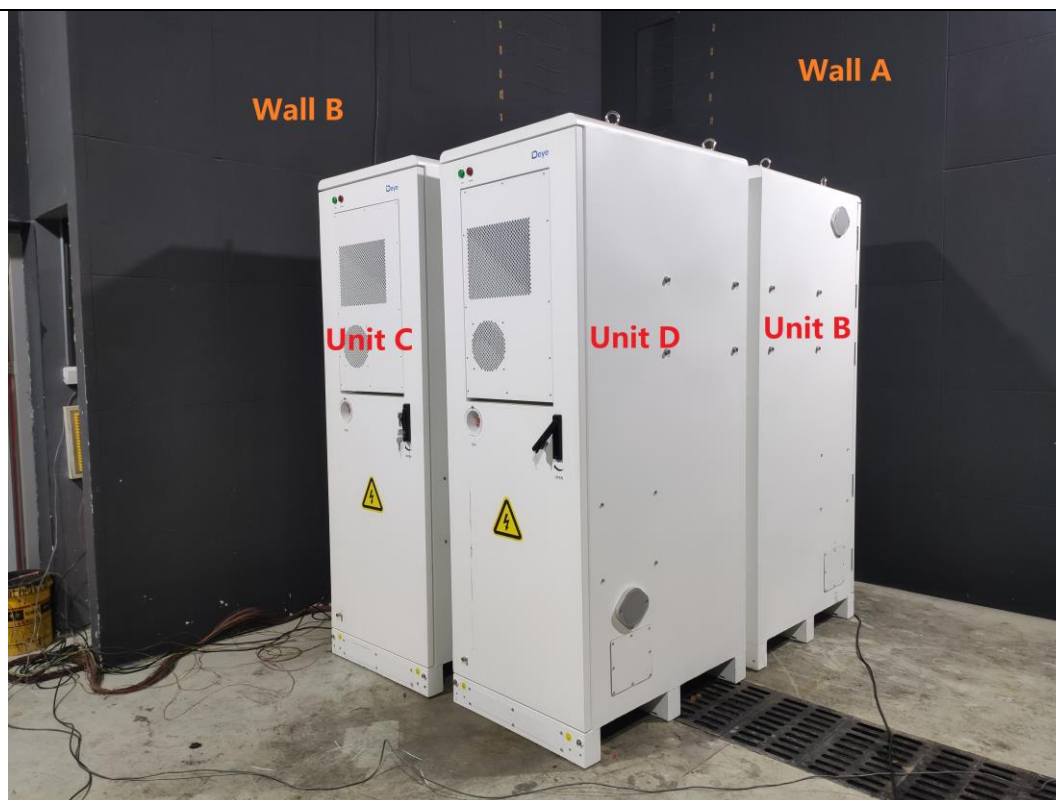
Figure 10b. View 02 of BESS units in testing room

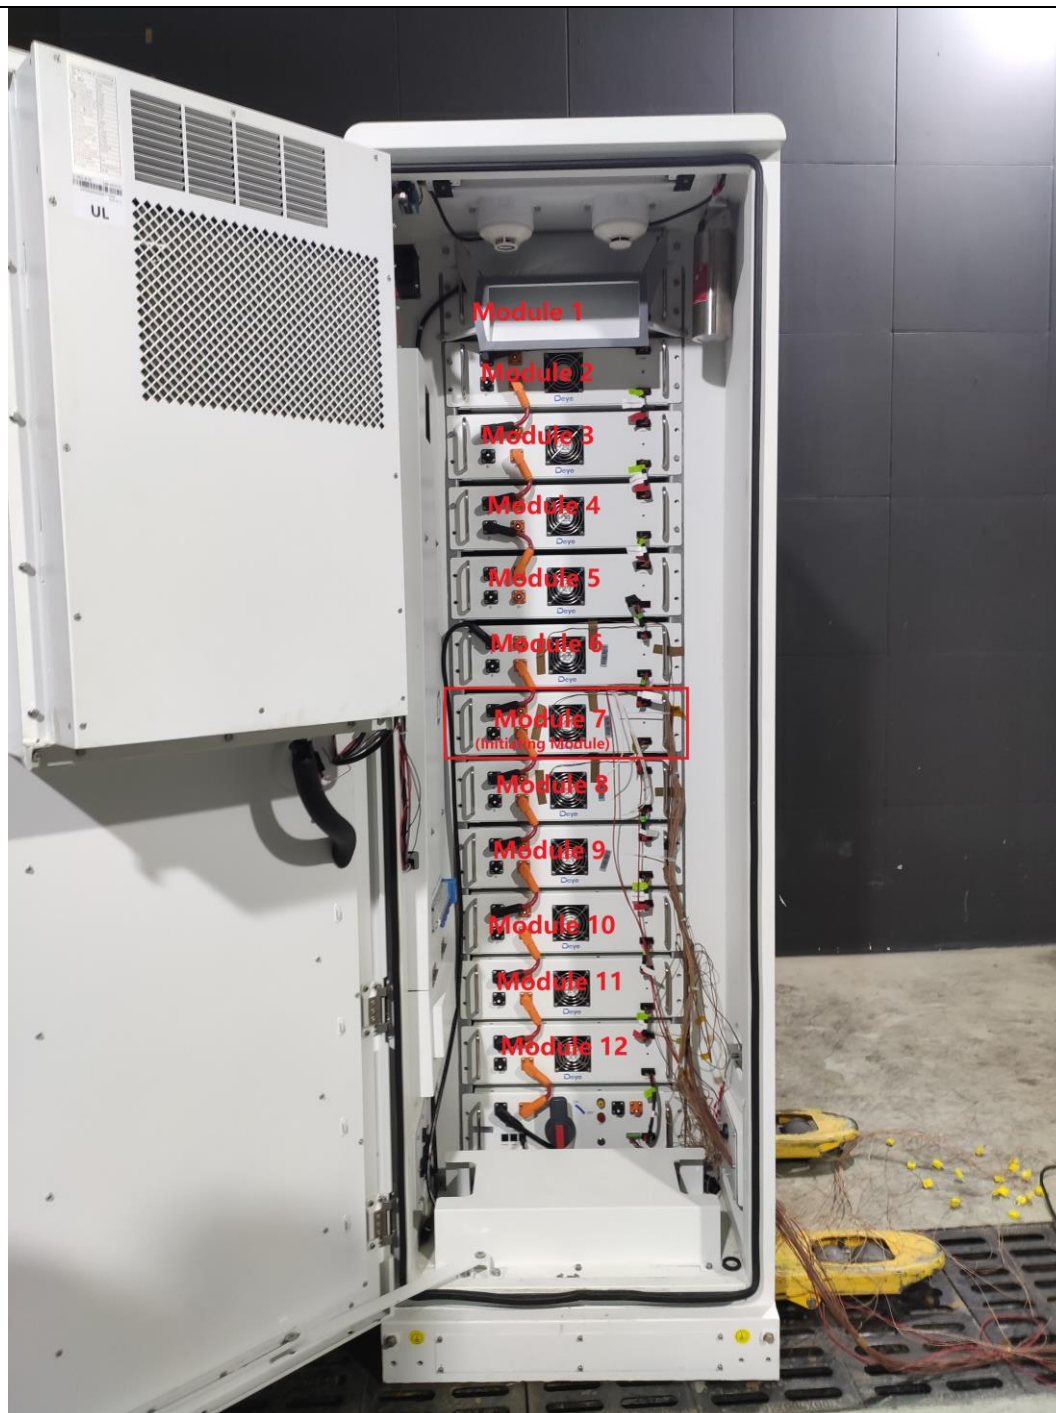
Description: Module 7 was selected as initiating module.

Figure 10c. View of initiating module in initiating BESS unit

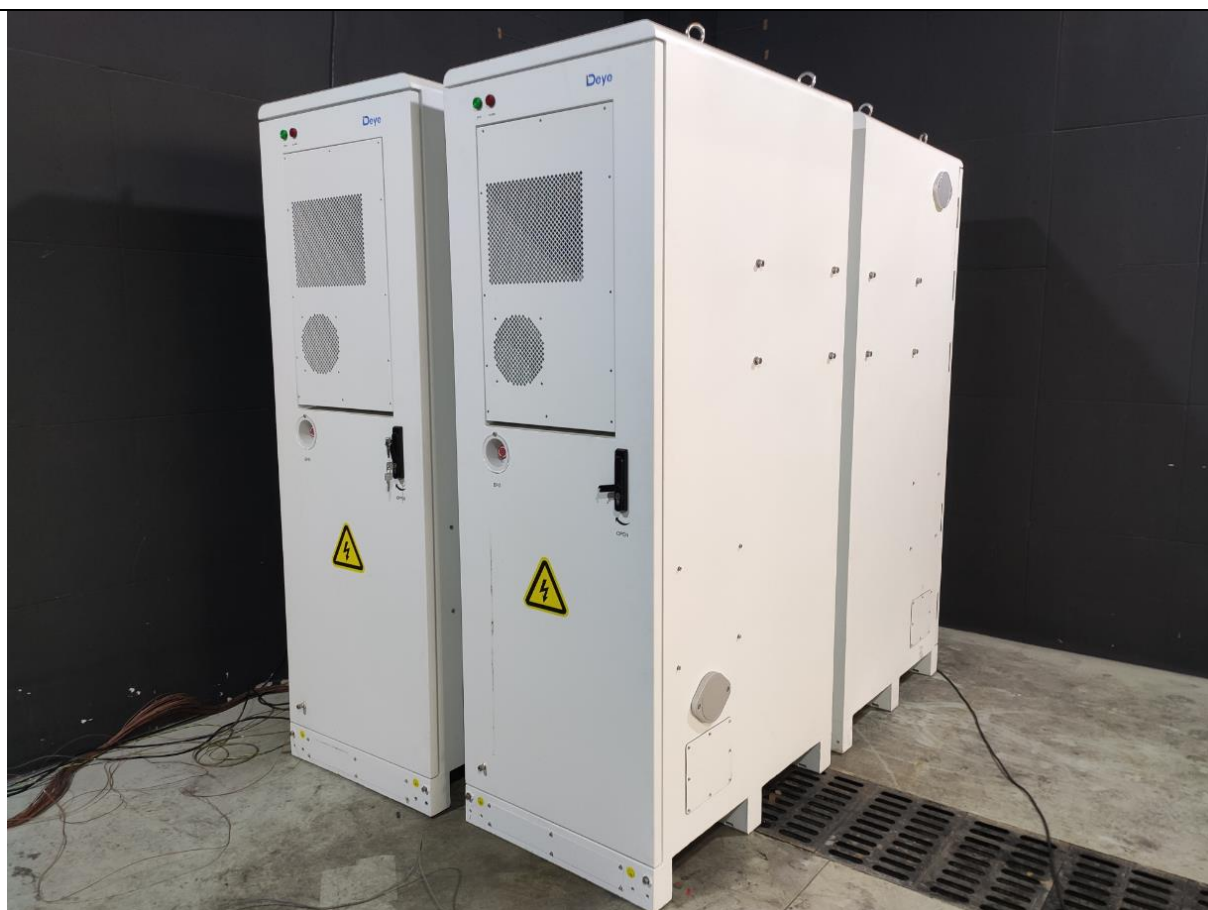
Figure 13. View of positioning of BESS units in testing room.

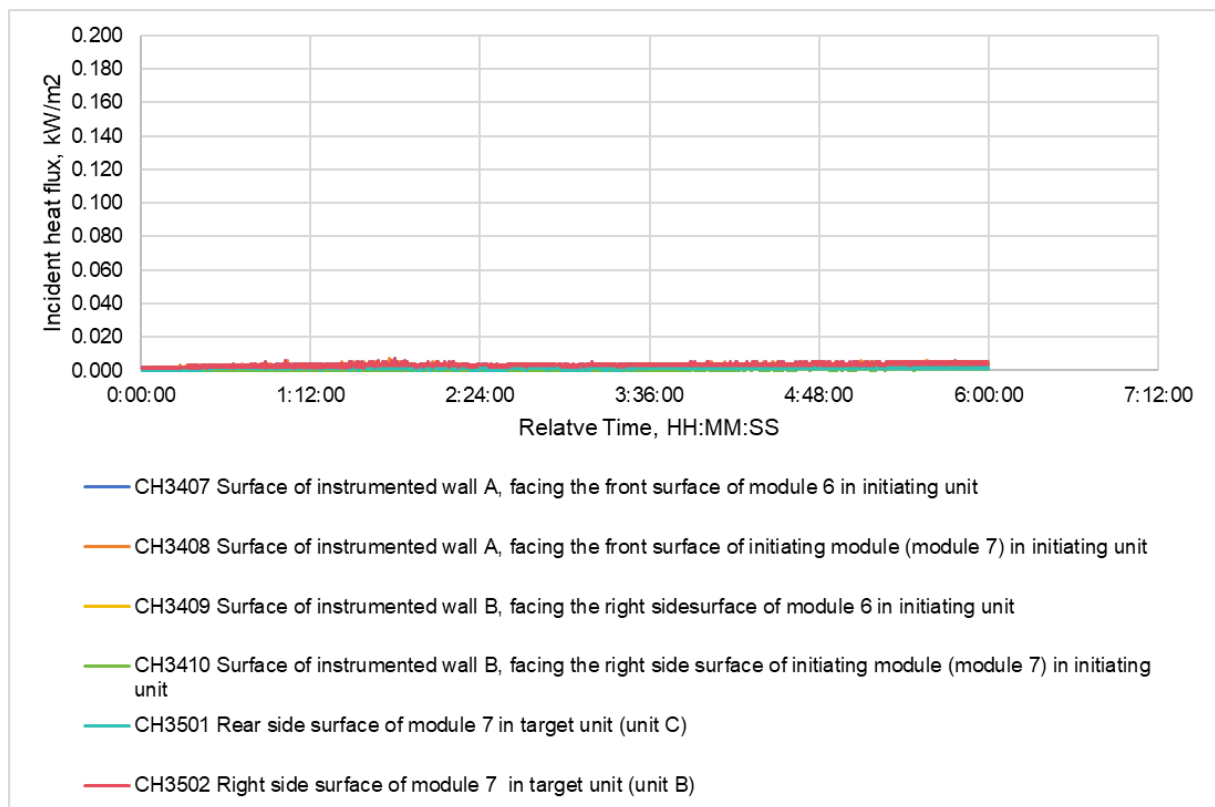
| Heat Flux ID | Description of location |
|---|---|
| CH3501 | Rear side surface of module 7 in target unit (unit C) |
| CH3502 | Right side surface of module 7 in target unit (unit B) |

Figure 15. Incident heat flux on instrumented wall surfaces and target units

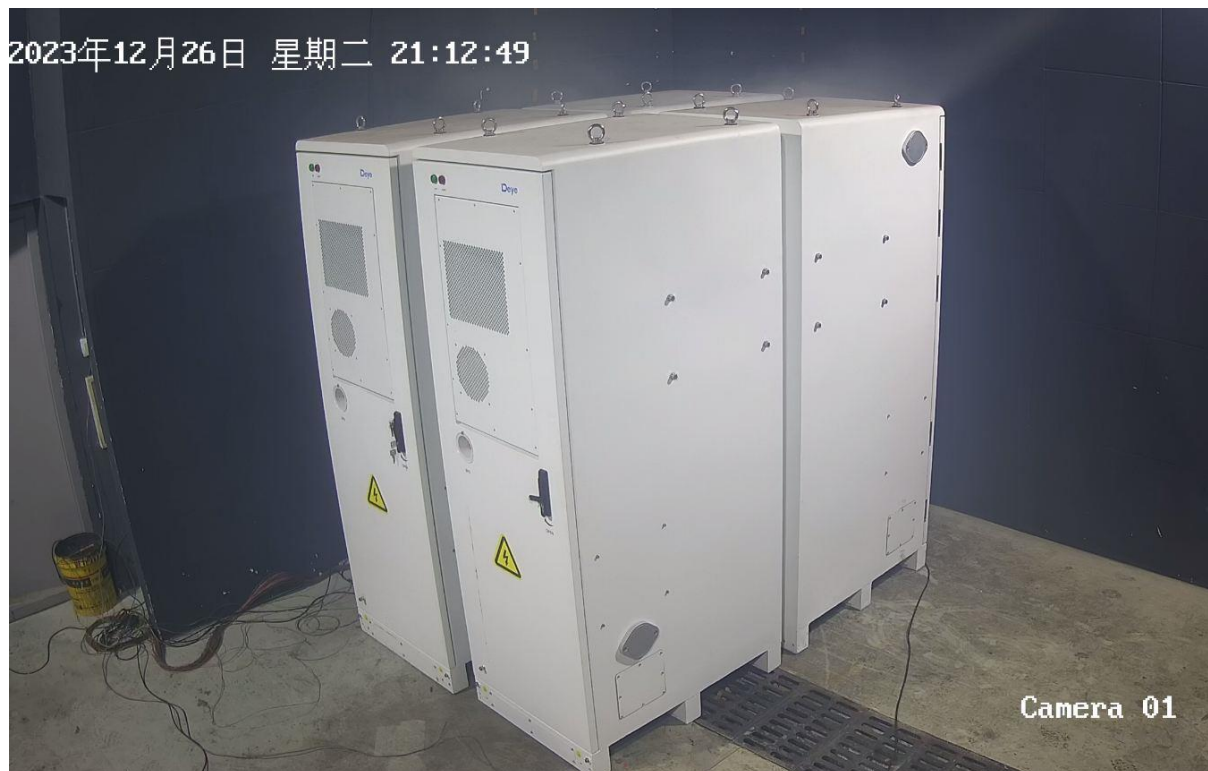
Figure 19. Photo of event (E3) during test

| Time (HH: MM: SS) | Relative Time (HH: MM: SS) | Event ID | Event | Description | Photo Reference |
|---|---|---|---|---|---|
| 21:12:49 | 00:57:58 | E3 | Initiating Cell Venting | Smoke release observed. | Figure 19 |

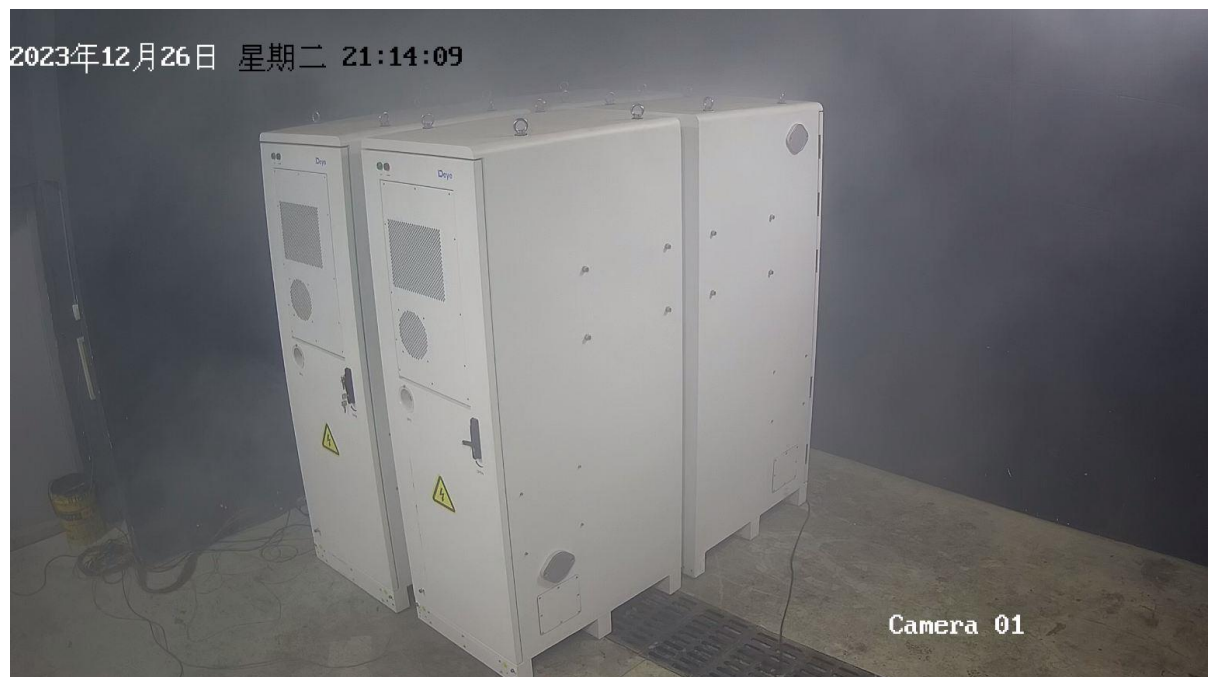
Figure 20. Photo of event (E4) during test

| Time (HH: MM: SS) | Relative Time (HH: MM: SS) | Event ID | Event | Description | Photo Reference |
|---|---|---|---|---|---|
| 21:14:09 | 00:59:18 | E4 | Thermal Runaway Onset | Thermal runaway confirmed through temperature curve. Smoke release observed. Heaters de-energized. | Figure 20 |

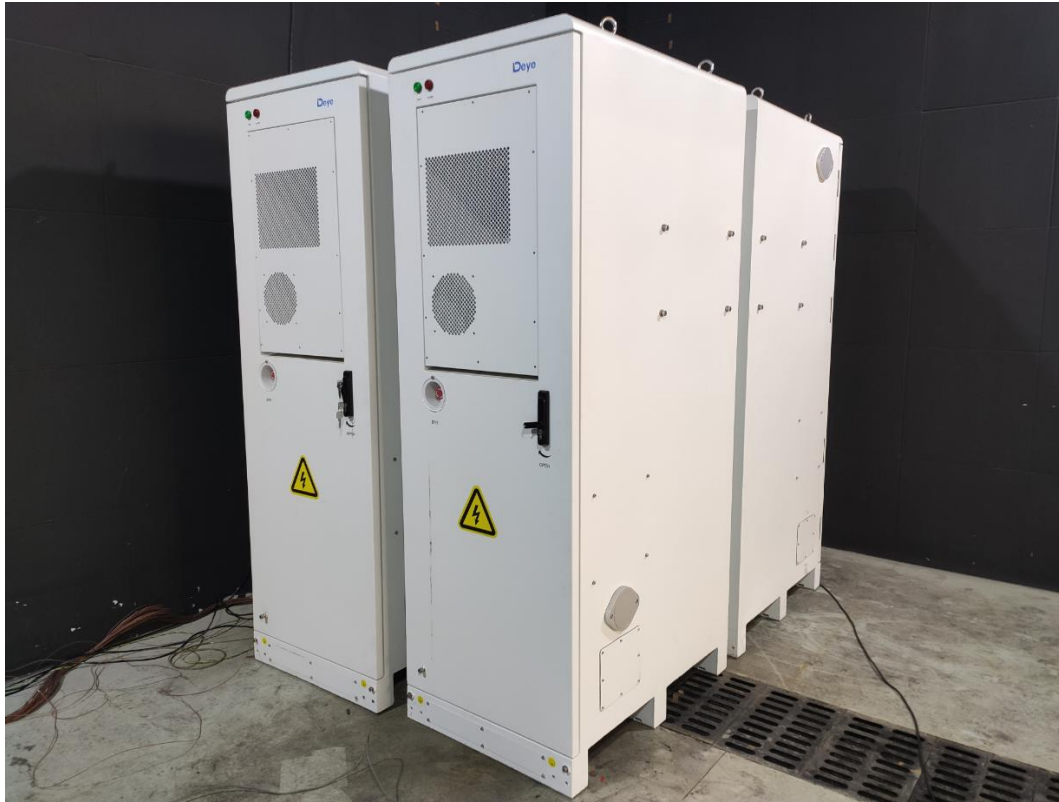
Figure 21. Photo 01 of after test\_ BESS units

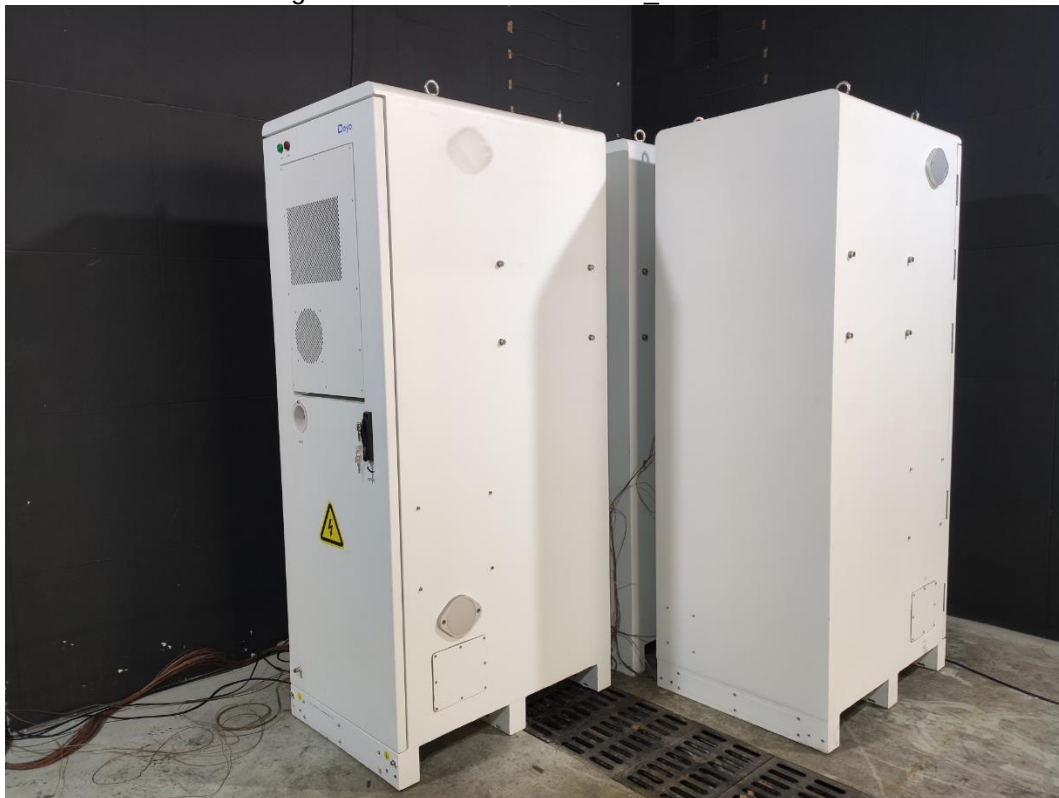
Figure 21a. Photo 02 of after test\_ BESS units

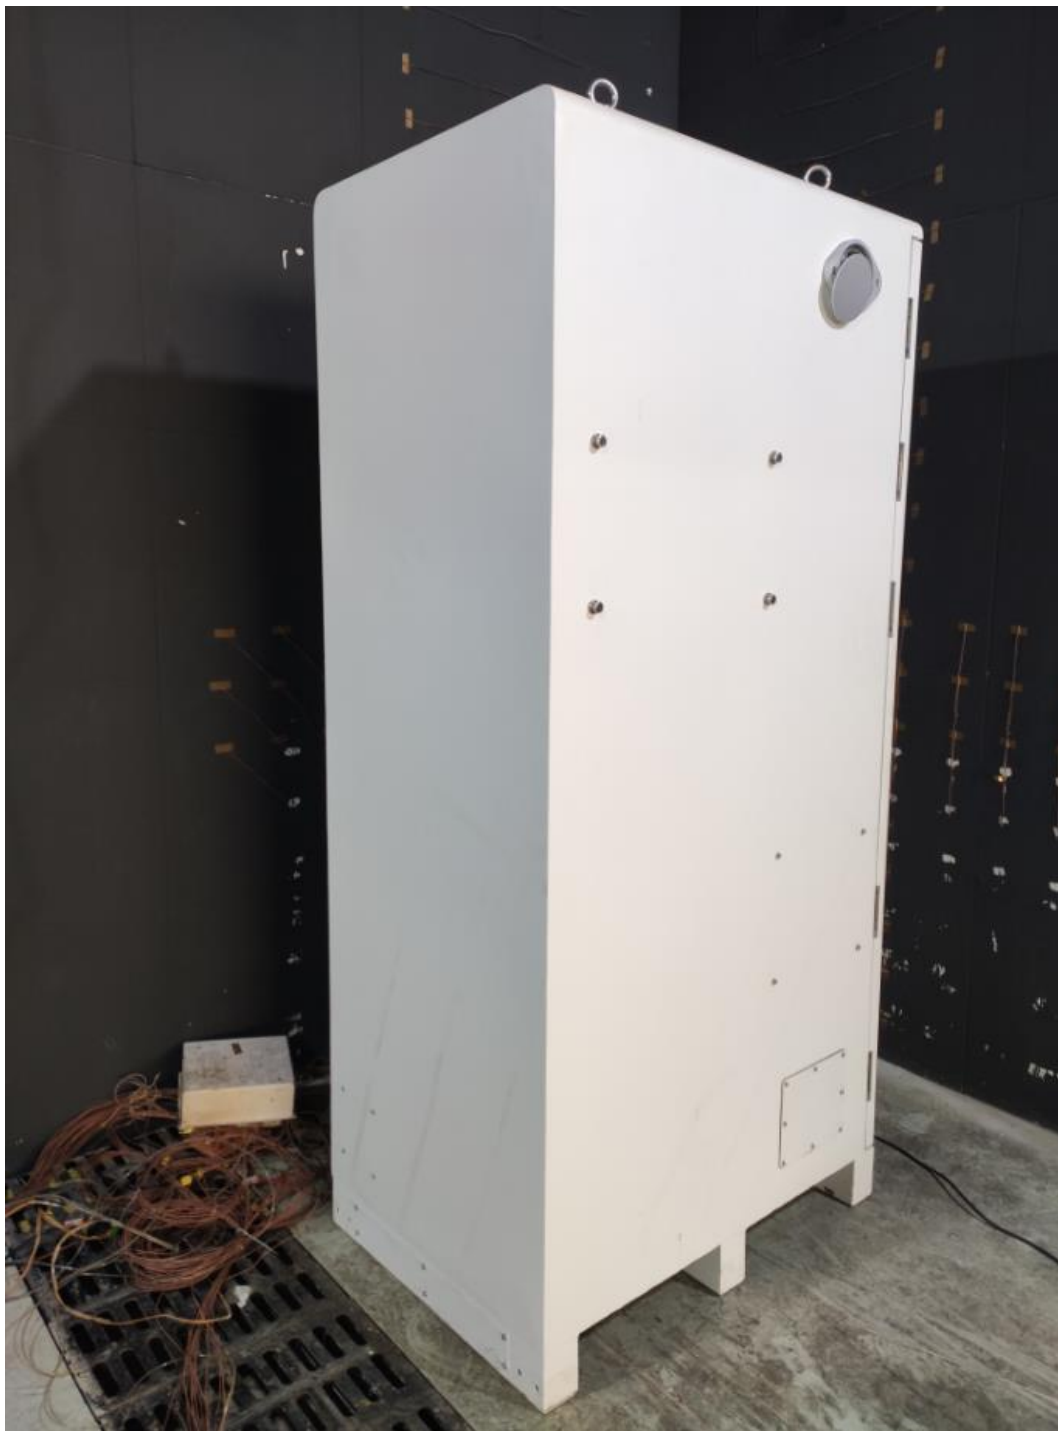
Figure 21b. Photo 03 of after test\_ BESS unit
